# Mill Brook Corridor and Wellington Park Revitalization Project Summary

August 2018

*100% Schematic Design Final Report*

Weston & Sampson

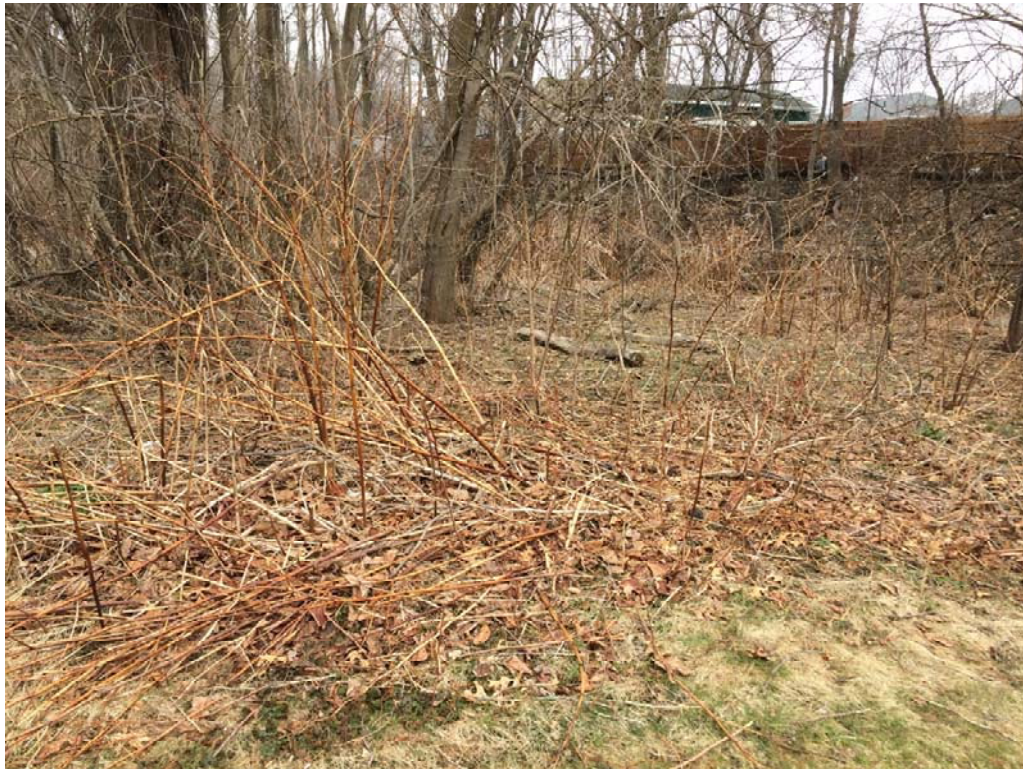
The most dominant invasive species, by far, was Japanese knotweed (*Fallopia japonica*). The largest patch of knotweed was located at the western edge of Wellington Park (see Photo 1). GPS points Inv-1 through Inv-4 were used to identify the outer limits of this knotweed patch. This area was approximately 6,800 square feet (sf), or 0.16 acres.

Photo 1. Knotweed at western edge of Park; winter dormant period shown.

The most dominant invasive species at the site is Japanese knotweed (*Fallopia japonica*). The largest area of knotweed is located on the western edge of Wellington Park and should be the primary focus of any invasive species management plan. It has been suggested that this area might be re-graded to provide additional flood storage. If this were to occur, removing all of the topsoil, along with the knotweed, its root system, and seeds in the soil, would be an optimal method of removal. While this method would include more disruption, it is preferred because virtually all of the invasive plant material would be removed from site with a small probability of regrowth. If regrading does not occur, because of the sheer volume of knotweed, one method that could work well for management is to cut down the knotweed in late May or early June, and then spray a non-glyphosate herbicide in late summer, during the flowering period. Alternatively, the cut and dab method could work. The cut and dab method is considered the preferred management strategy of the Conservation Commission. These management options would need to occur over a several year time period.

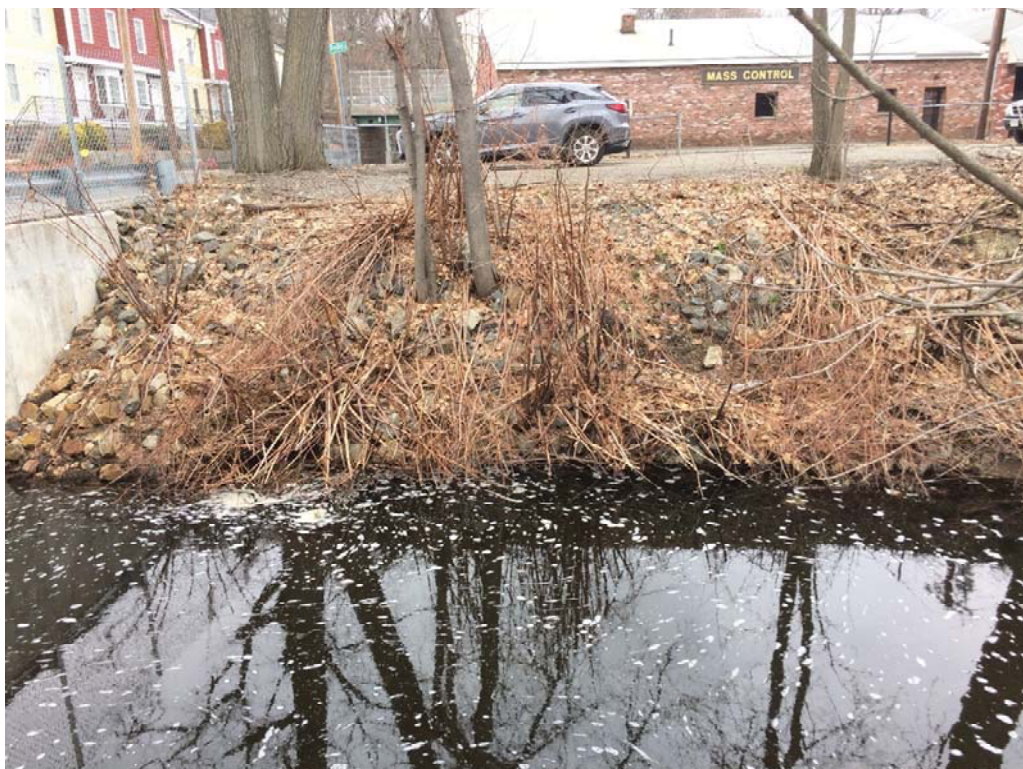
Longer, thinner patches of knotweed were located along the bank of Mill Brook. These smaller patches were located along both the southern bank (between Inv-5 and Inv-6 (500 sf), Inv-9 and Inv-10 (2,700 sf)) and the northern bank (between Inv-7 and Inv-8 (900 sf), and at the Brattle Street culvert (800 sf – see Photo 2). GPS points were not taken near the Brattle Street culvert due to access issues.

Photo 2. Knotweed at north bank by Brattle Street; winter dormant period shown.

Where the knotweed is along the bank in long, thin patches, the cut and dab method would likely work better since there are fewer clumps of plants in these areas. The mowing method likely will not be an option as it may be impracticable to get a machine to these areas.

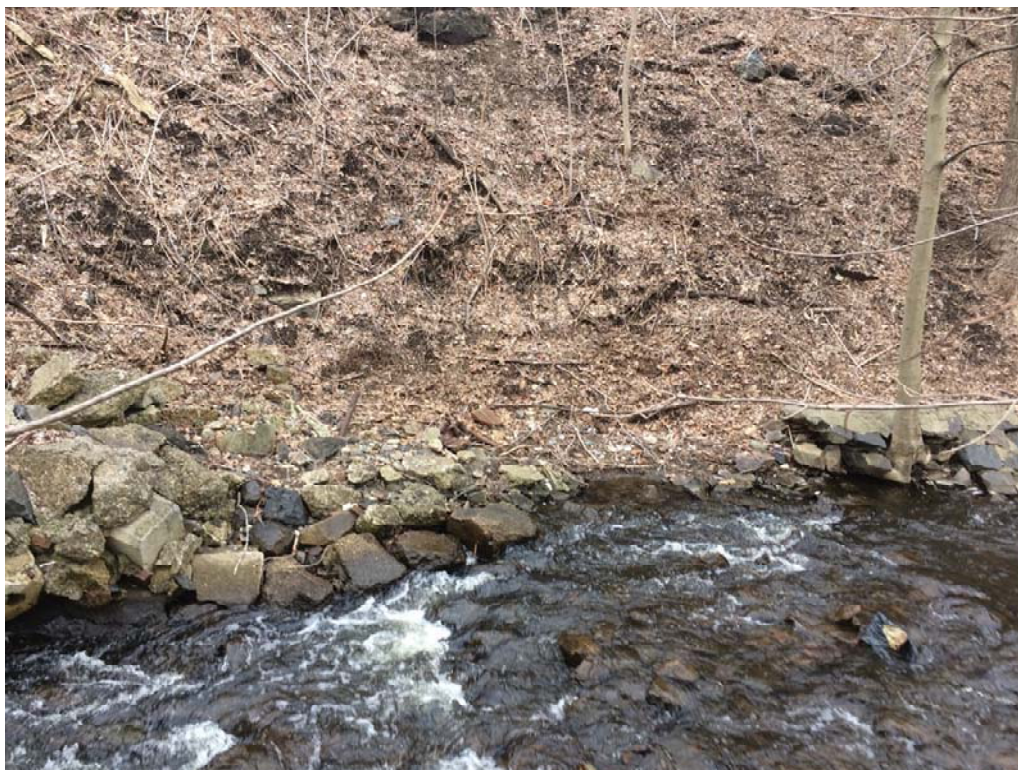
Erosion-1 is located on the southern bank just west of the foot bridge. The bank has been armored, but erosion in this area has broken through the stone/cement bank. A steep slope is immediately upgradient of this erosion area. (See Photo 3 for this erosion area.)

Photo 3. Erosion area west of bridge, southern bank. (Private property)

All four of the erosion areas would benefit from a bank stability project. One such project was conducted on the southern bank of Mill Brook within this limit of work. It was constructed over 10 years ago and remains in excellent condition. (See Photo 4 for this bank stabilization “living wall” structure.)

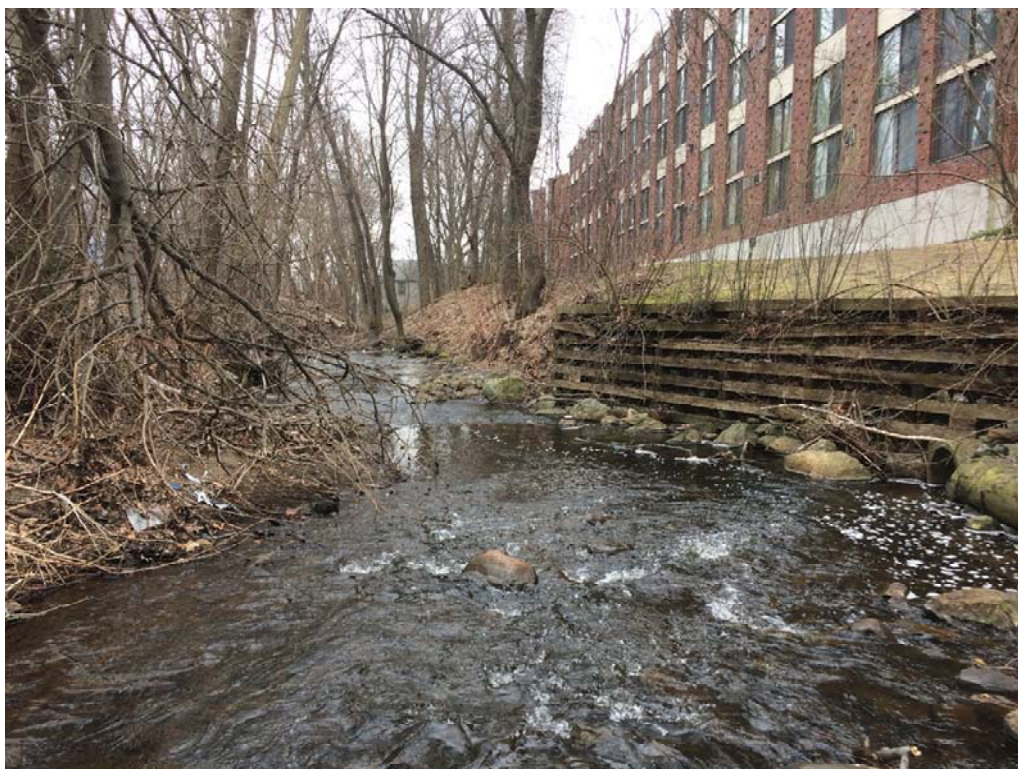
Photo 4. Erosion control “living wall” project along Mill Brook. (Private property)

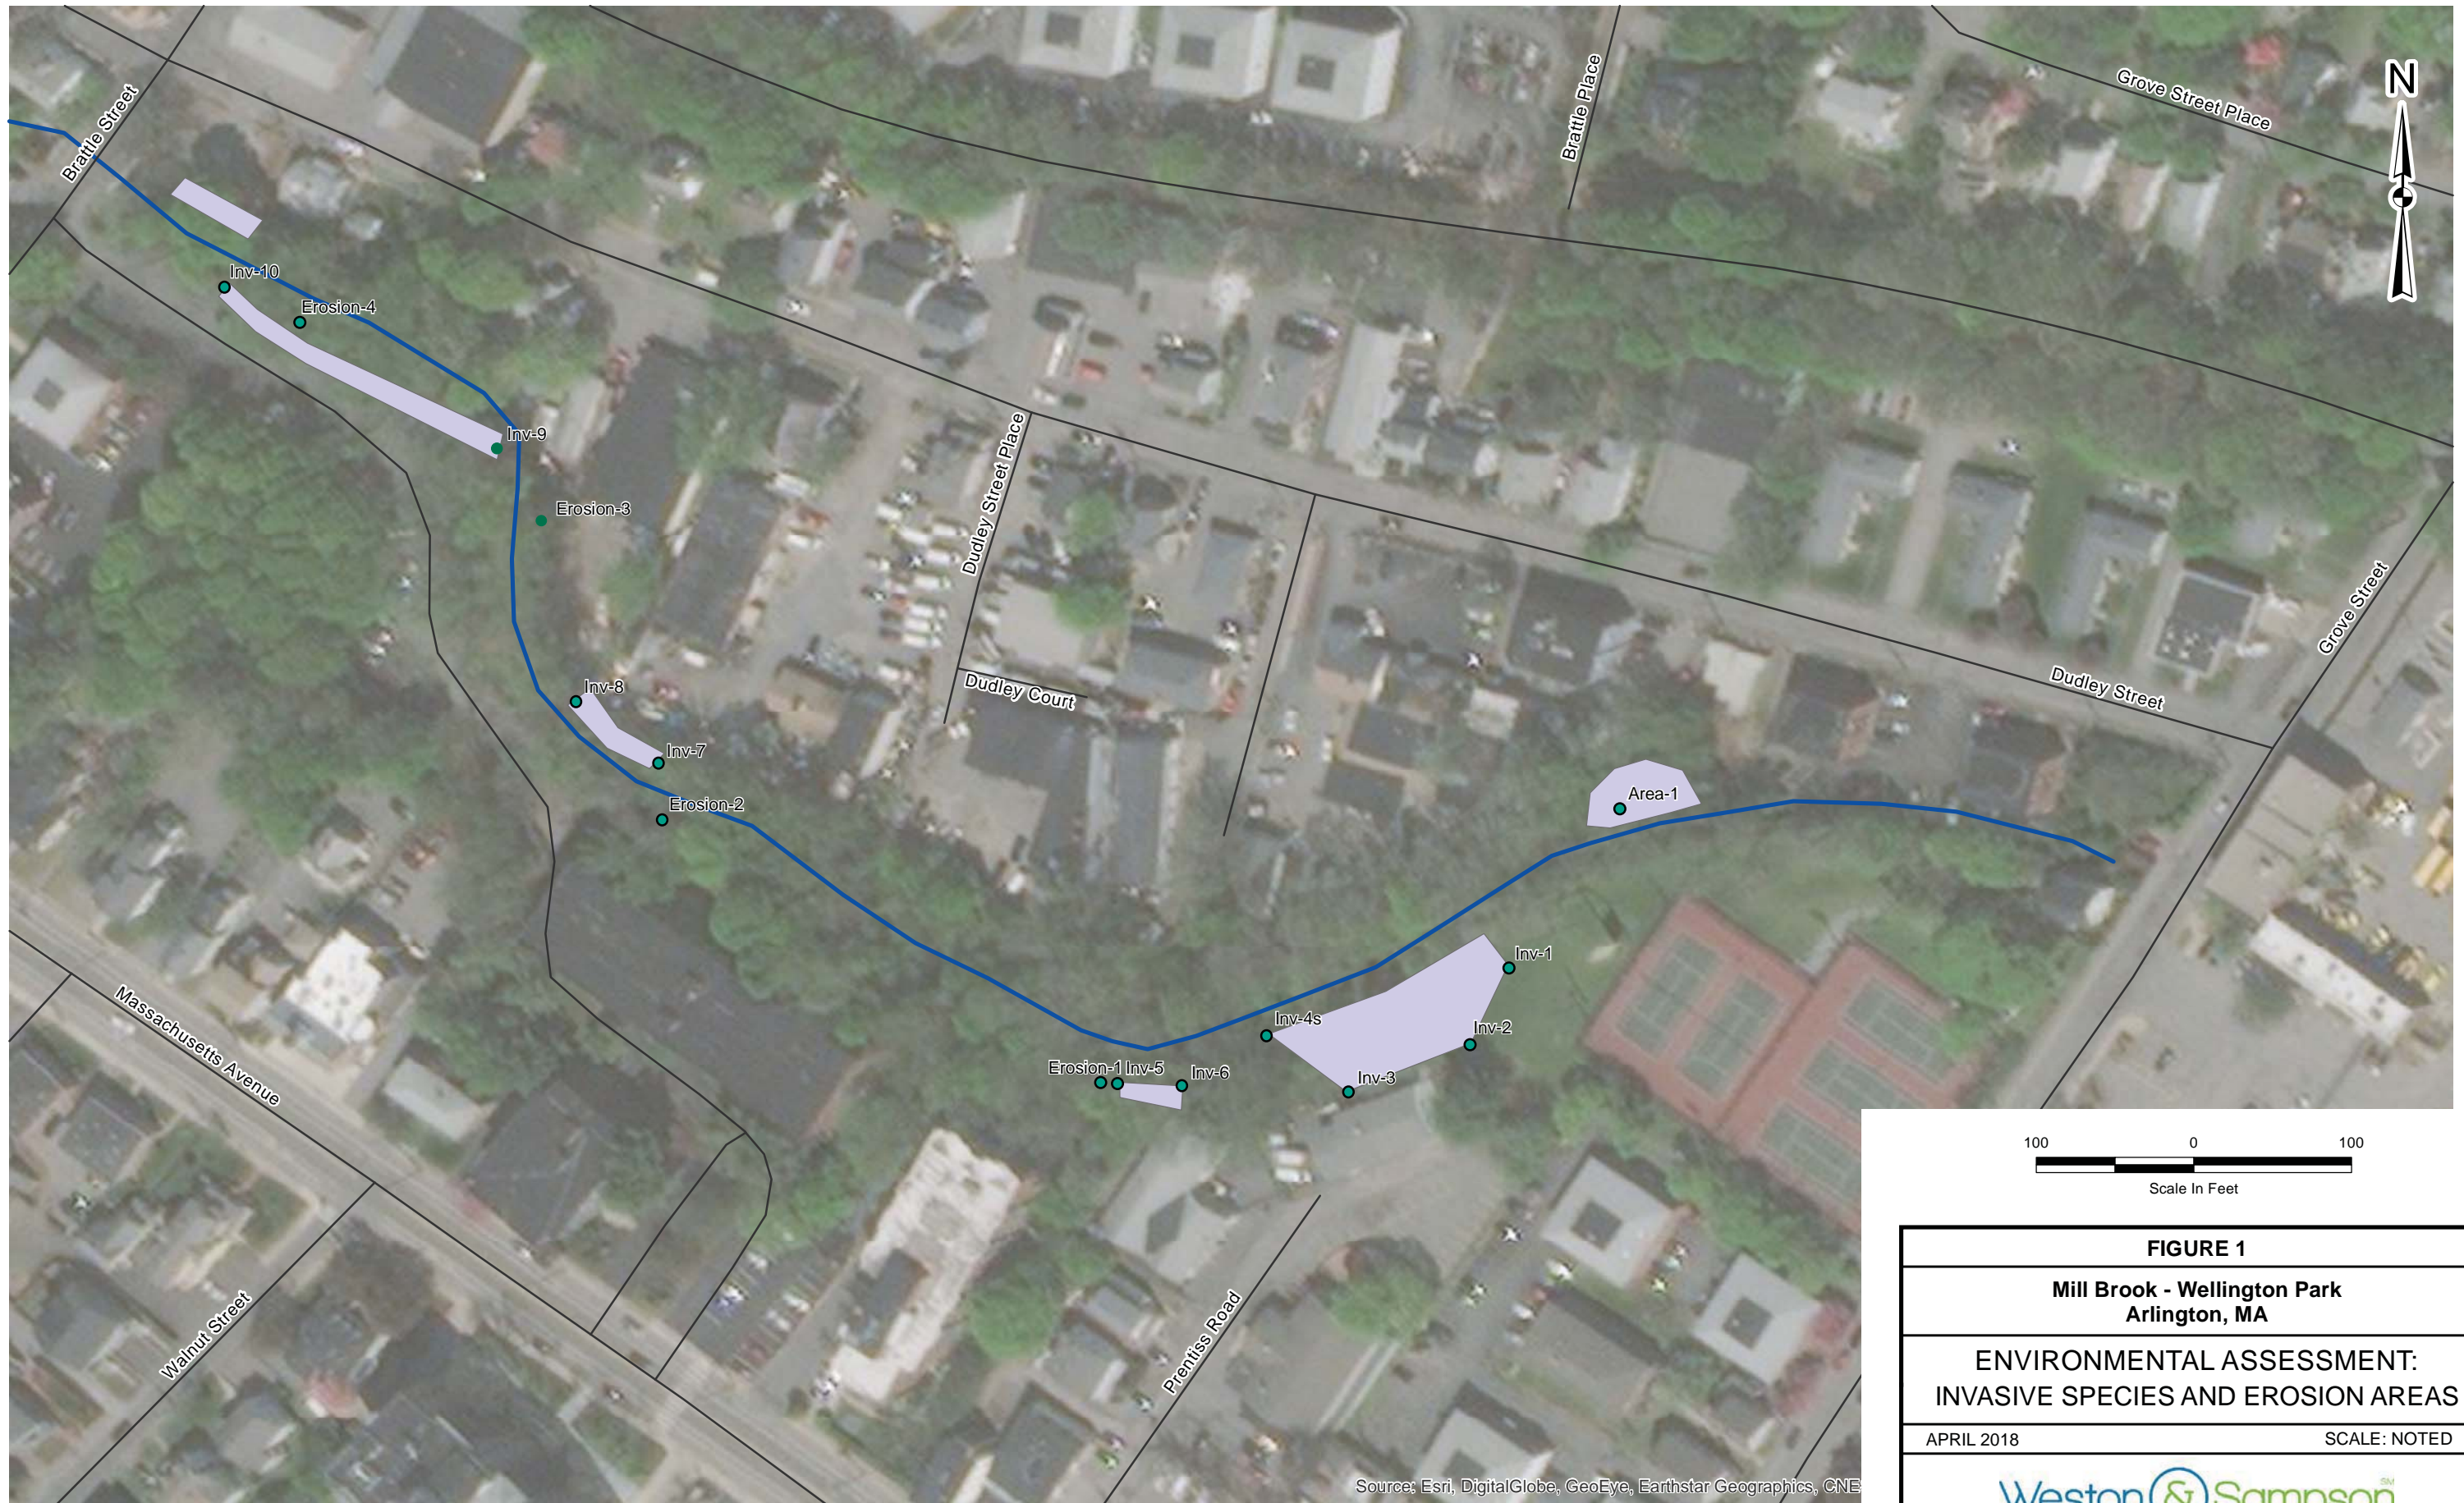
<b>FIGURE 1</b>	
<b>Mill Brook - Wellington Park Arlington, MA</b>	
<b>ENVIRONMENTAL ASSESSMENT: INVASIVE SPECIES AND EROSION AREAS</b>	
APRIL 2018	SCALE: NOTED

A total of six areas containing invasive species were identified (see Figure 1). Some of the invasive species identified at the site included:

A total of four bank erosion areas were identified (see Figure 1). Three of these locations are on the southern bank (GPS points Erosion-1, -2, and -4) and one of these locations (Erosion-3) is on the north bank.

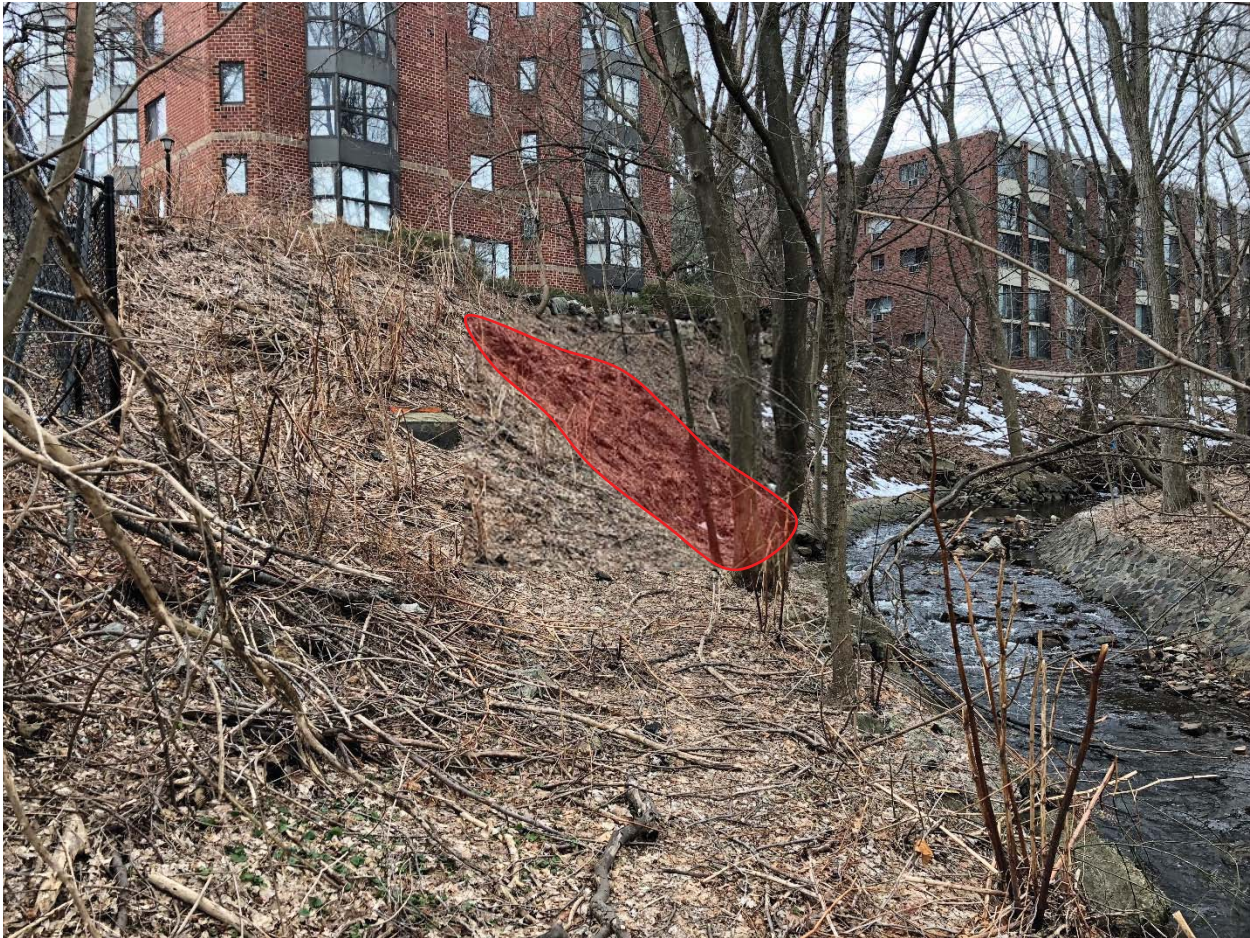
Based on visual observation of topography, it appears the section between the footbridge and the “living wall” (which roughly corresponds with the section between “Erosion-1A and Erosion-1B” and “Erosion-2A and Erosion-2B” points (see Figure 2 and Photos 5-10) is most favorable for potential stormwater storage during rain events.

Photo 5: Looking west toward "Erosion-1A". (Private property)

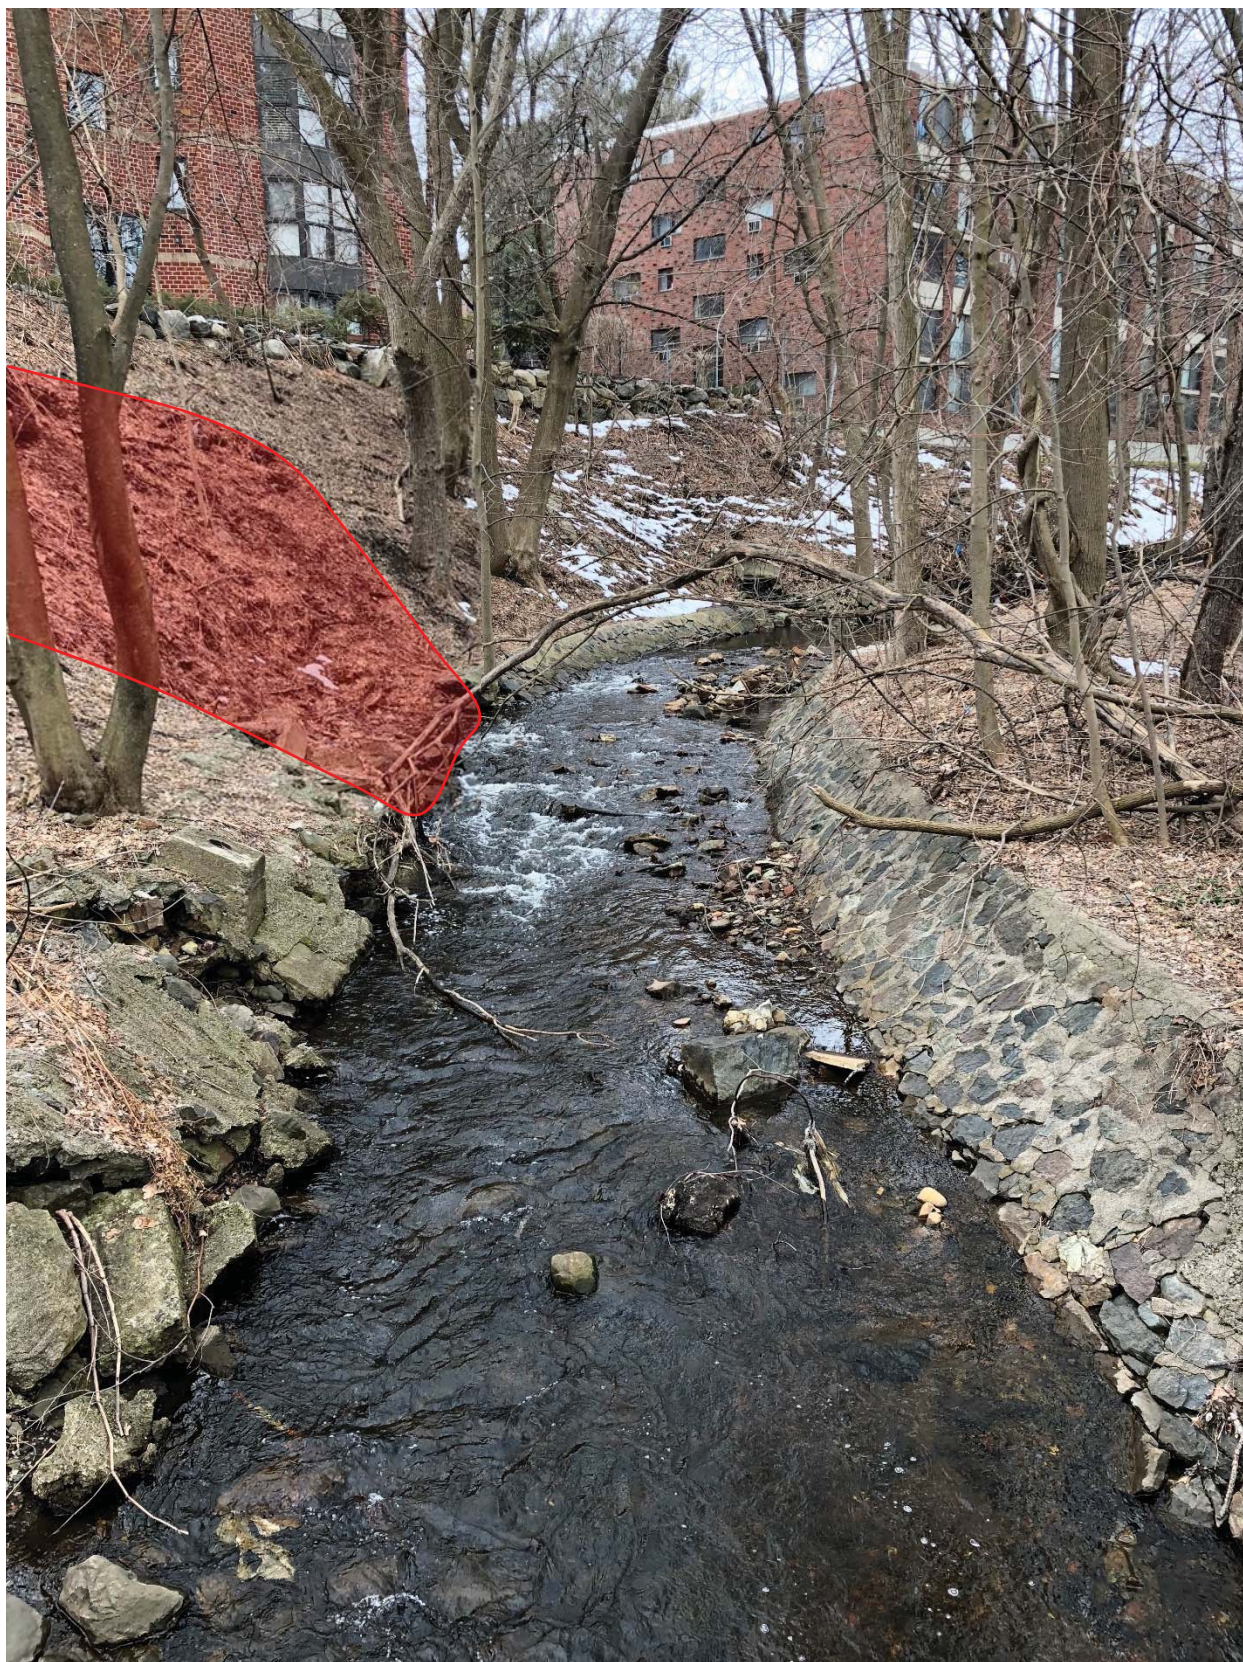
Photo 6: Looking west toward south bank and “Erosion-1B”. (Private property)

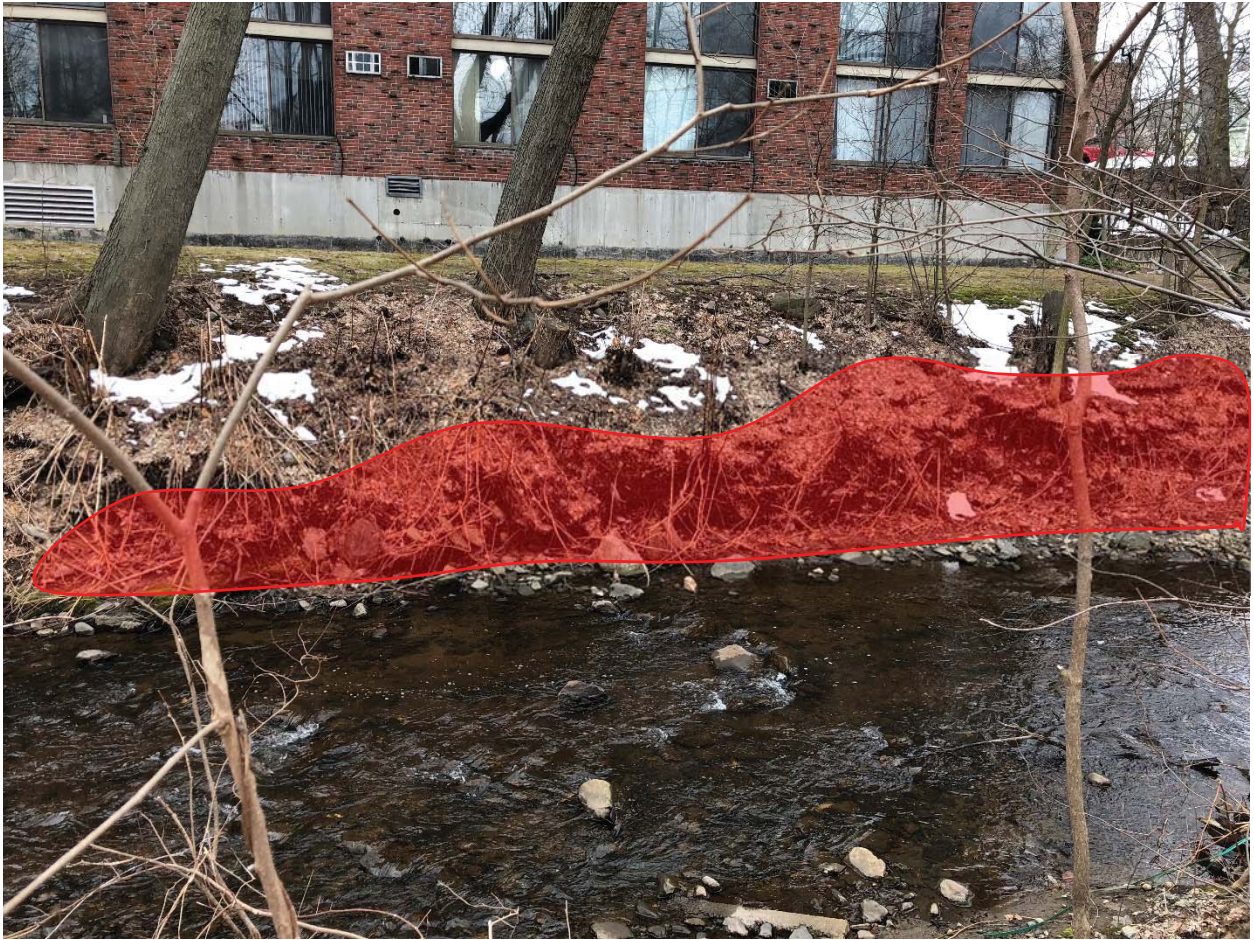
Signs of erosion and scarp were observed at four locations, as shown on Figure 2. Of the four areas, “Erosion-1” and “Erosion-2” located on the south bank were observed to have eroded more significantly than the other two locations. Erosion-2 area is immediately adjacent to and downstream of the “living wall” (see Photo 8). It appears erosion and scarp of the brook bank has advanced downstream of the erosion control “living wall” project, while the “living wall” has performed well against continued erosion. Erosion-1 area is just upstream of the footbridge and is generally located where the brook makes a turn. The erosion appears to be a surficial slope failure, suggesting possible scouring of the bank toe and eventual slope movement. Both locations should be monitored by the property owners for future movement.

Photo 7: Looking south toward south bank and “Erosion-2A”. (Private property)

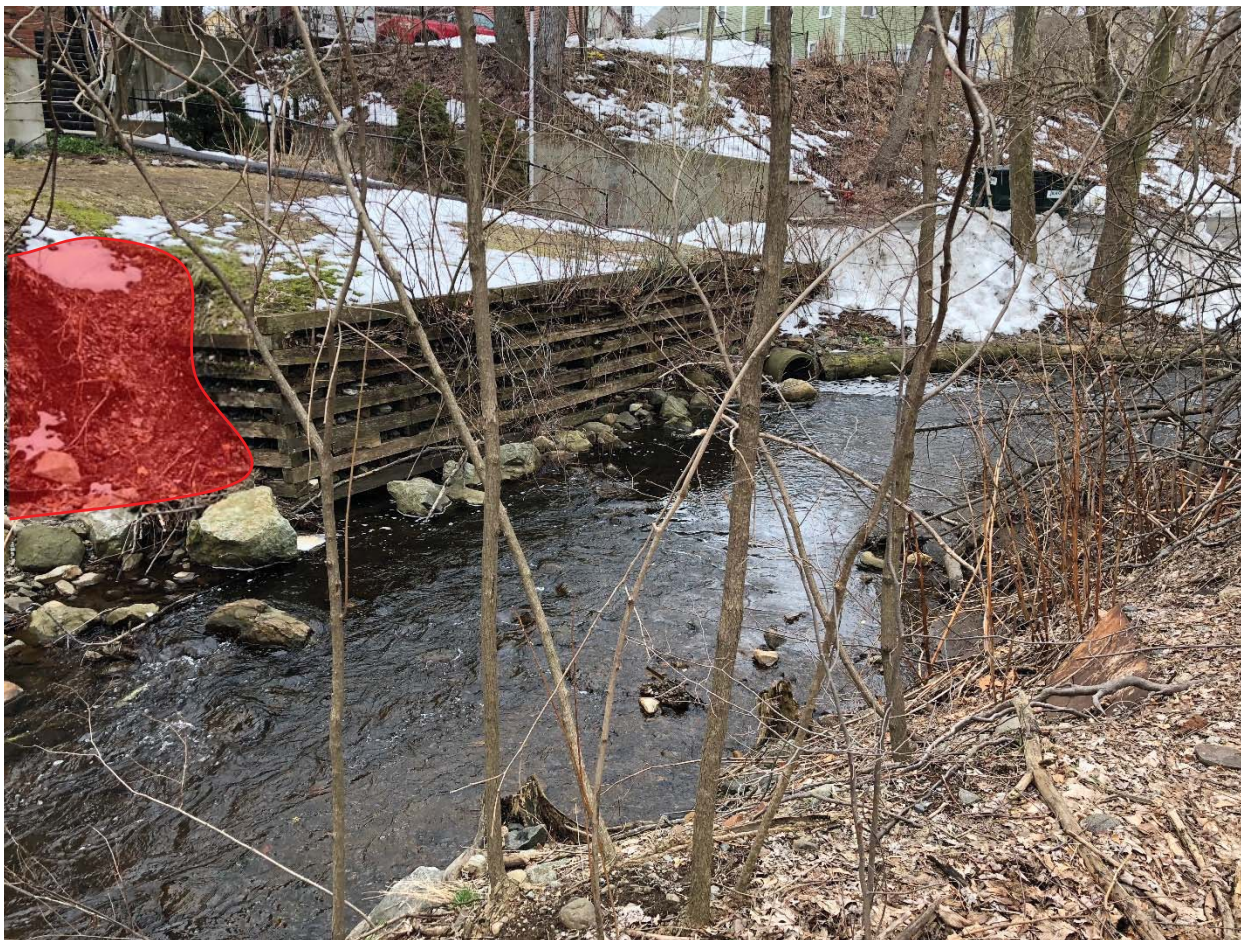
Photo 8: Looking south-west; “Erosion-2B” adjacent to “living wall”. (Private property)

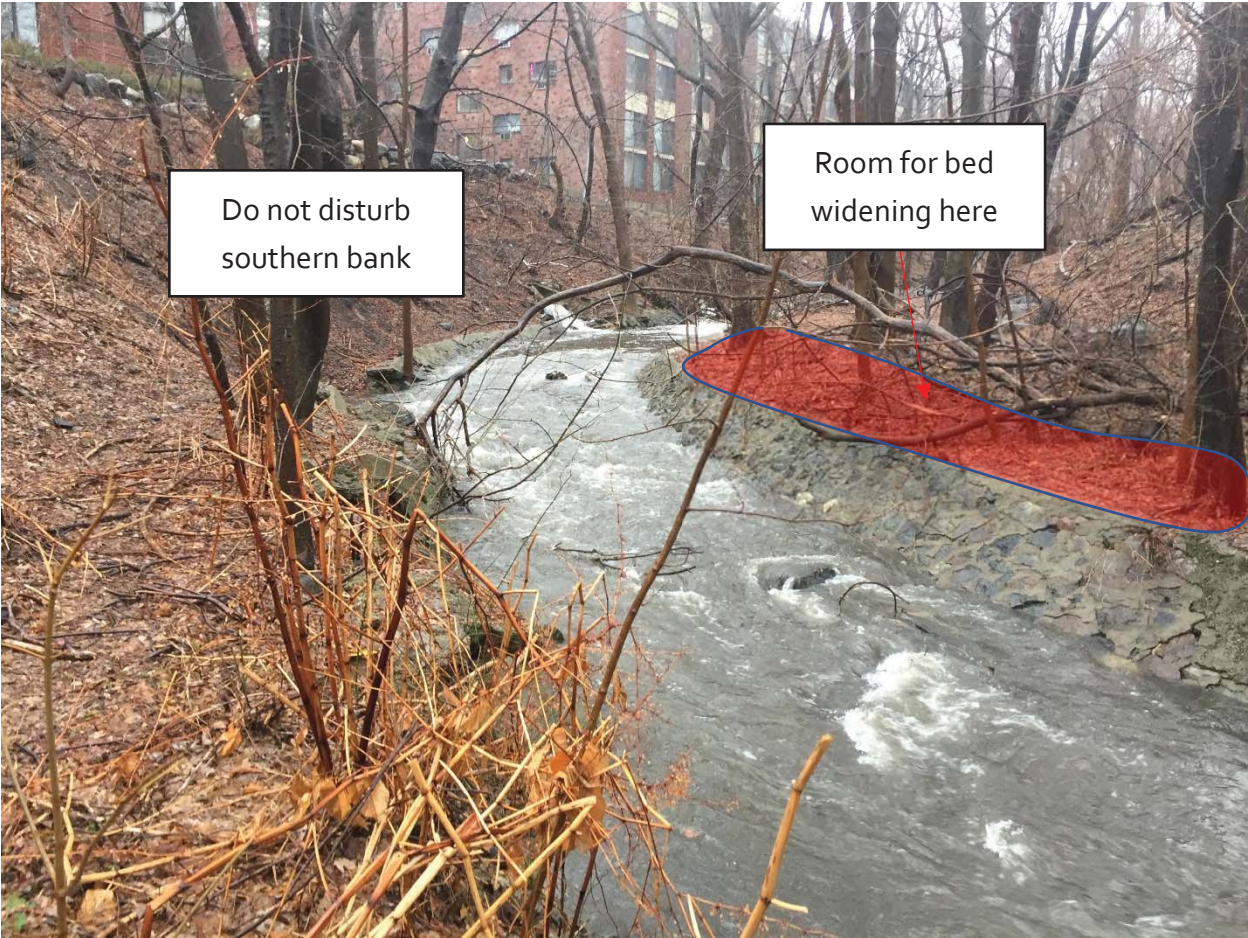
Based on visual observation of topography and the location of buildings on top of slope, if widening of the stream bed is considered, it should be widened towards the northern bank (see Photo 9). Based on erosion already observed on the southern bank, the toe of that slope should not be altered.

Photo 9: Looking west toward northern stream bed. (Private property)

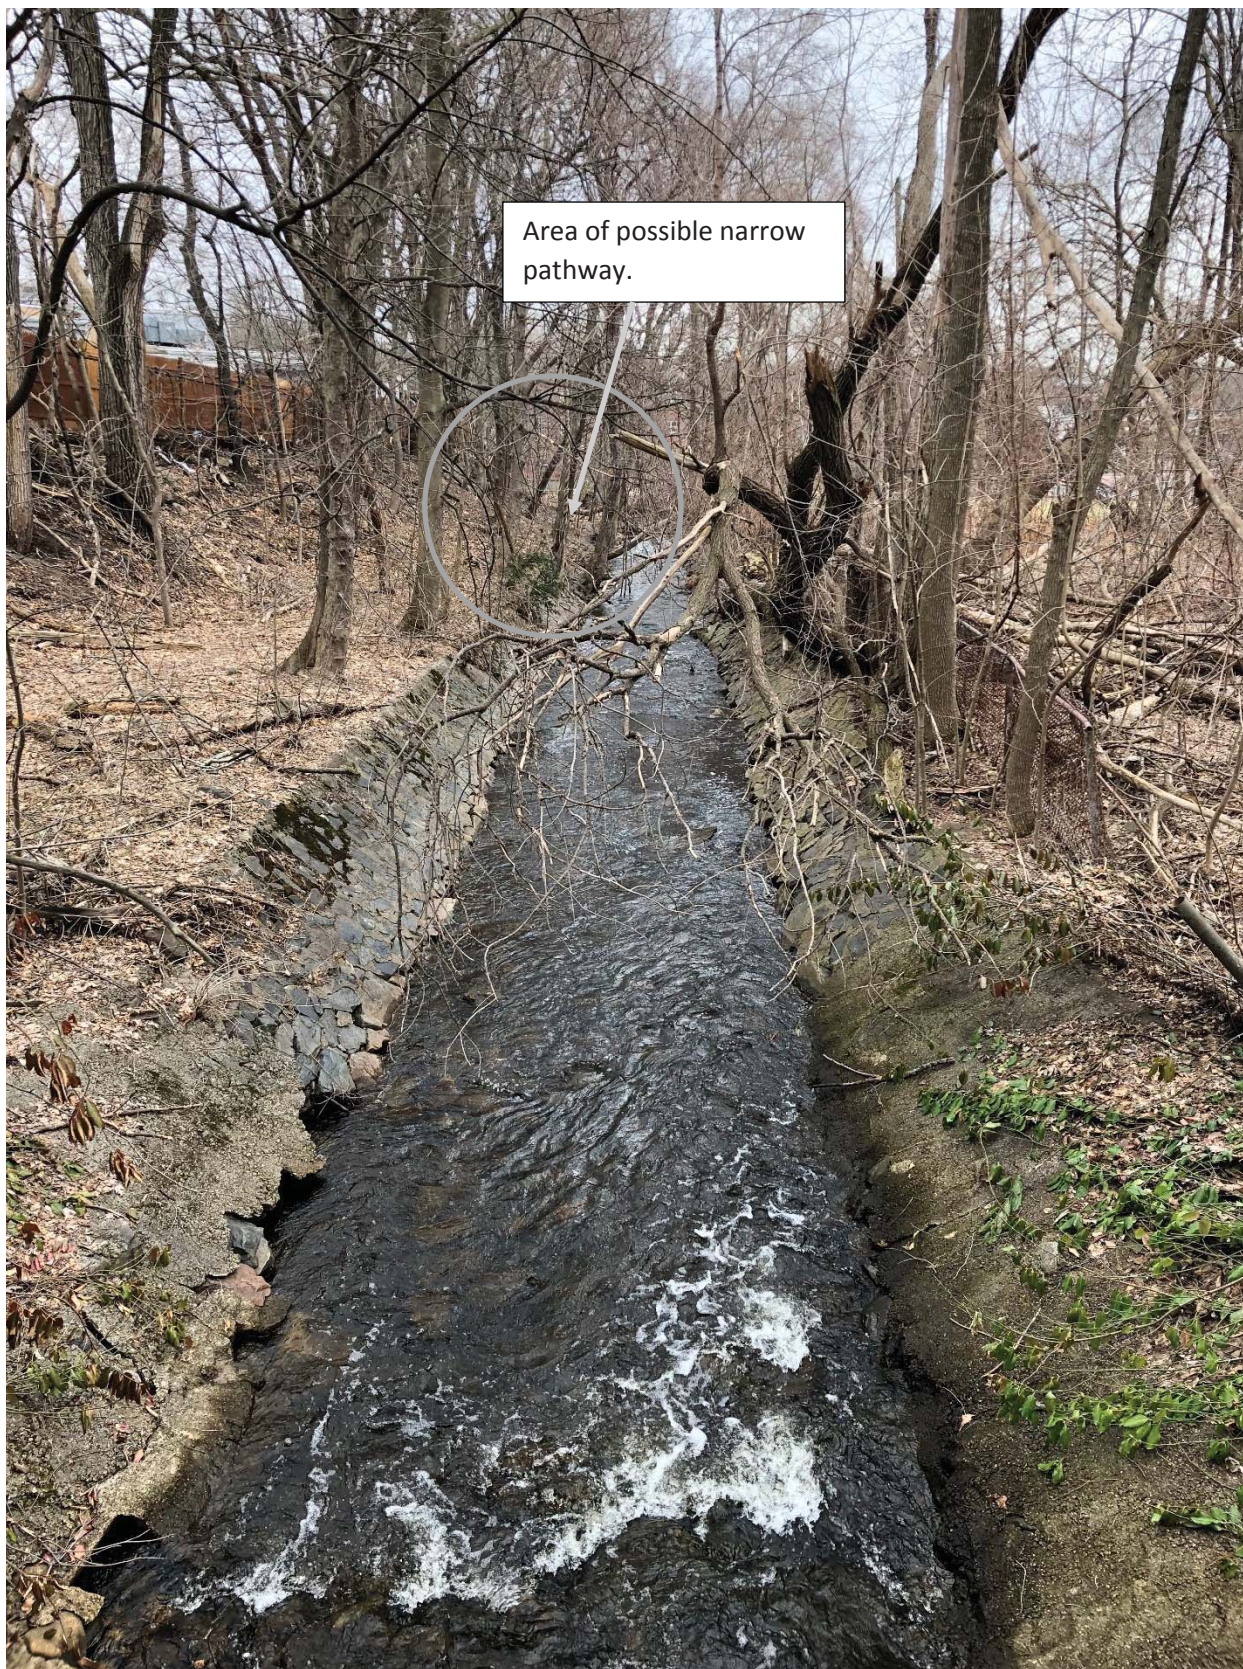
Based on visual observation of topography and building locations, if a pathway is considered on the northern bank to make a walking path “loop”, there is room for a narrow ( $\pm 5$  ft.) walkway, with a retaining wall to support the buildings on top of the slope (see Photo 10).

Photo 10: Looking east toward narrow pathway location.

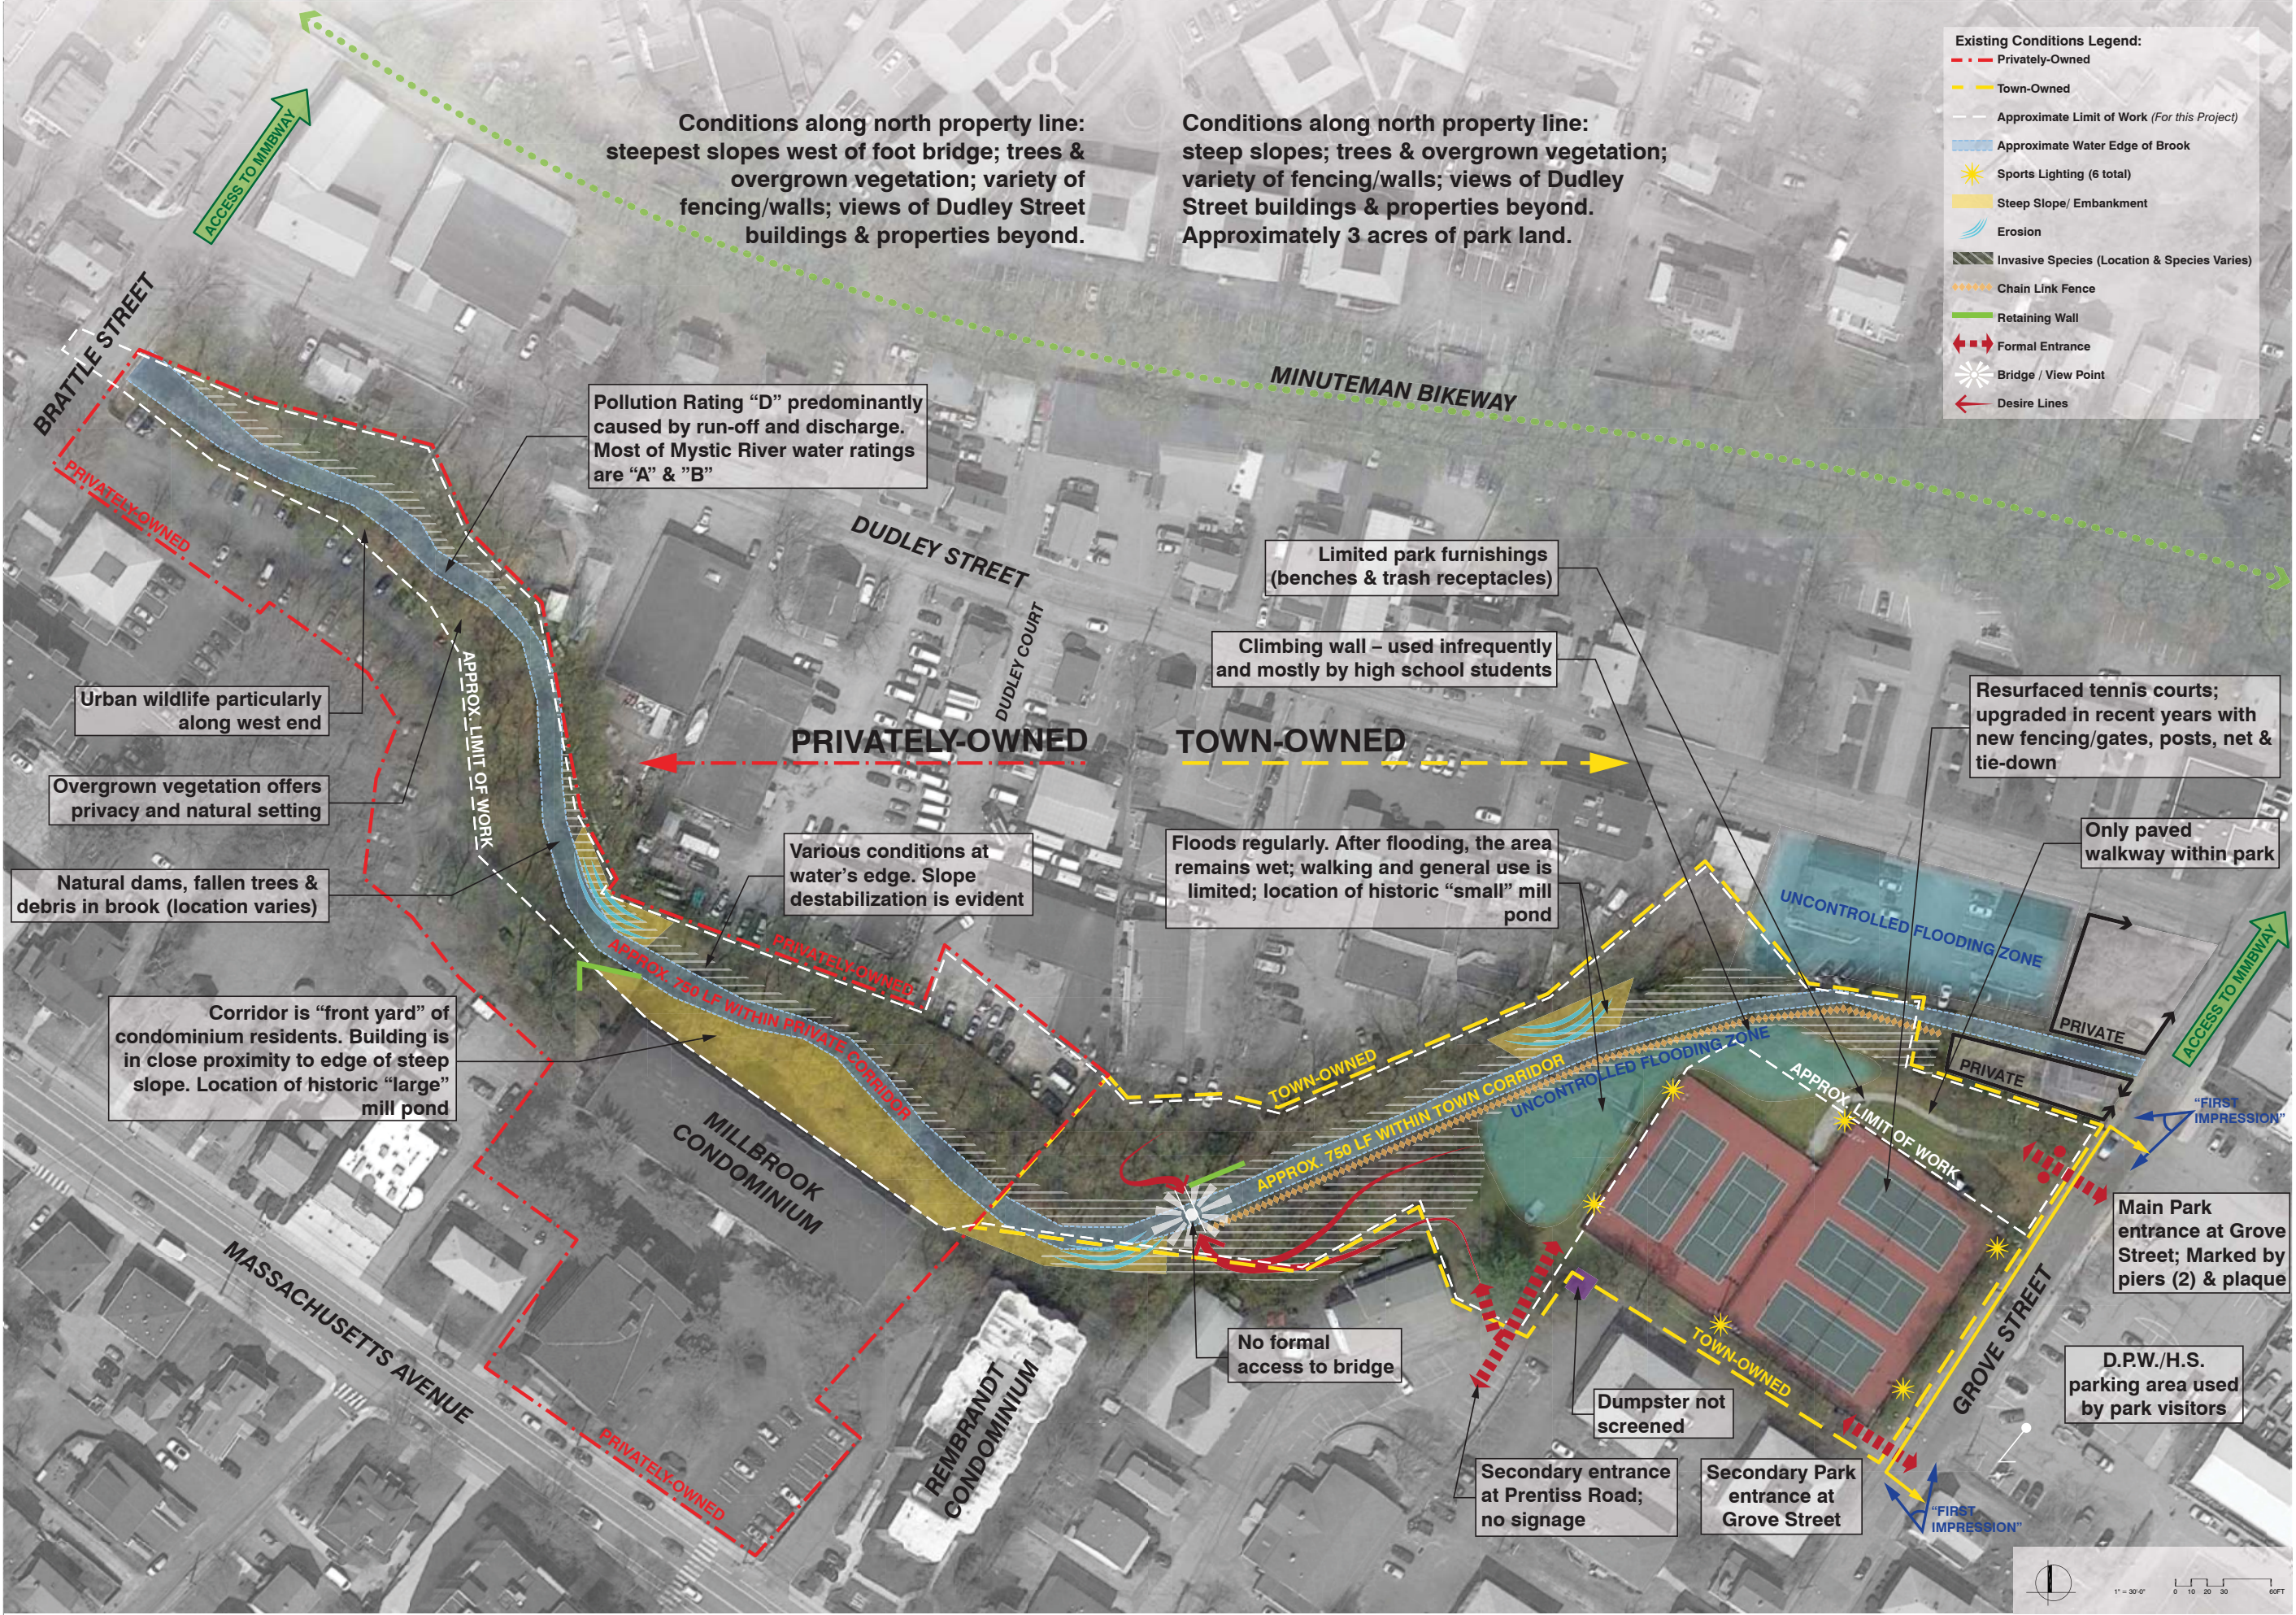
Pollution Rating "D" predominantly caused by run-off and discharge. Most of Mystic River water ratings are "A" & "B"

Floods regularly. After flooding, the area remains wet; walking and general use is limited; location of historic "small" mill pond

Natural dams, fallen trees & debris in brook (location varies)

Various conditions at water's edge. Slope destabilization is evident
